PRELIMINARY REPORT ON SEISMIC TESTING OF A FULL-SCALE SIX-STORY STEEL BUILDING

By
DOUGLAS A. FOUTCH
SUBHASH C. GOEL
CHARLES W. ROEDER

UNIVERSITY OF ILLINOIS
AT URBANA-CHAMPAIGN
URBANA, ILLINOIS
NOVEMBER 1986

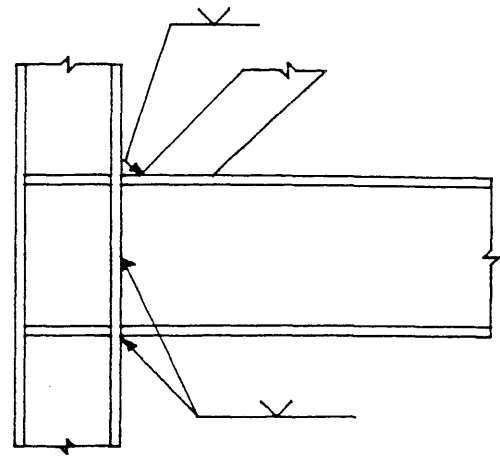
b) TYPICAL BEAM-COLUMN-BRACE
CONNECTION FRAME B

Because of this anomaly in the energy dissipation, a more careful inspection of the structure was made, and it was discovered that the beam panel zone between the first level K-braces failed during this test. A very unusual connection detail, by U.S. standards (see Fig. 2.2b and Fig. 2.5e), was used in this zone because of the unusual erection method described earlier. First the beam splice was placed in this region of potentially large bending moment. A bolted gusset plate was used to join the beam webs and the flanges and webs were later welded with complete penetration welds. Finally, the geometry of the connection resulted in

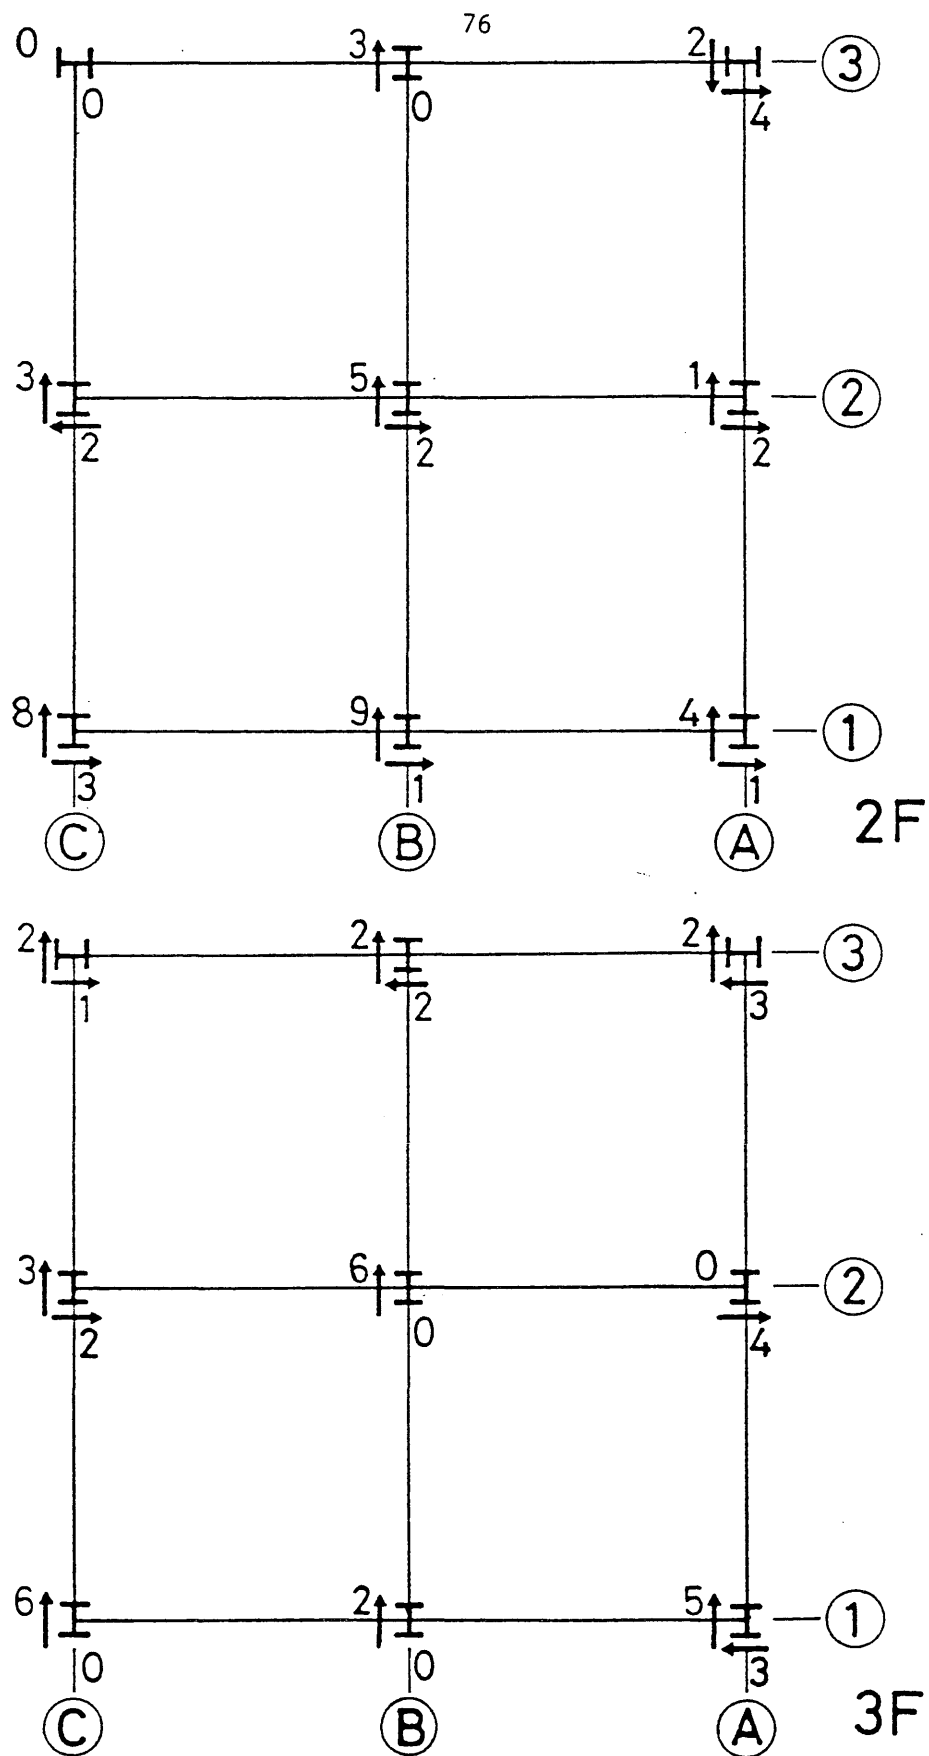
Fig. 2.14 Departures from vertical for the columns at the Z2 and Z3 levels

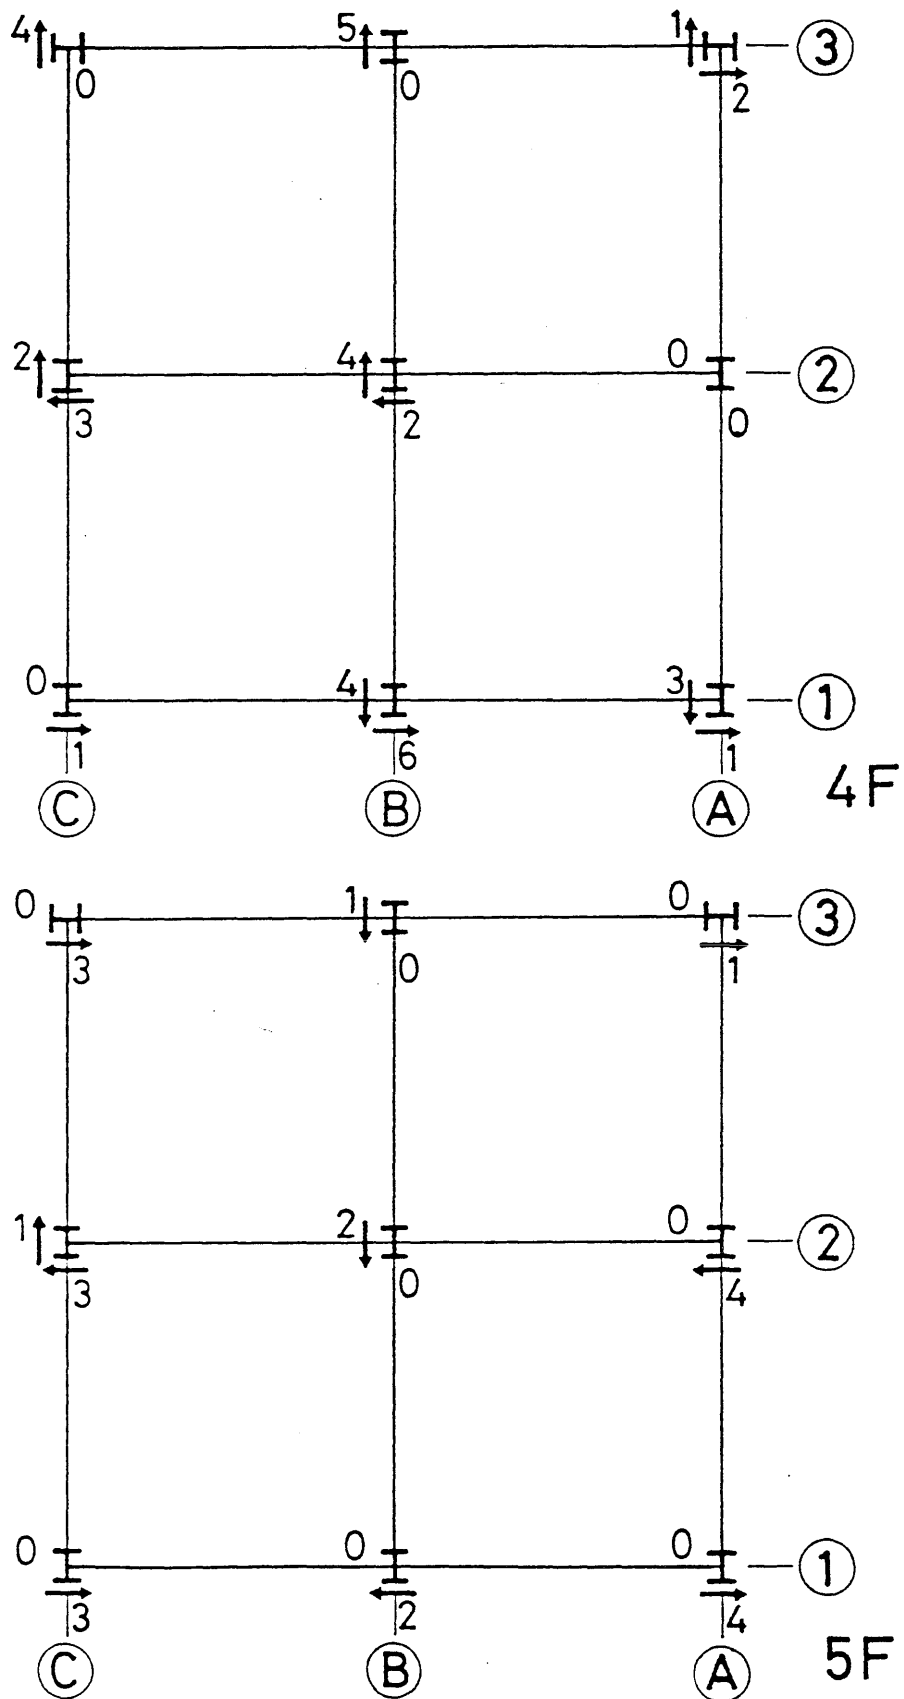
Fig. 2.15 . Departures from vertical for the columns
at the Z4 and Z5 levels

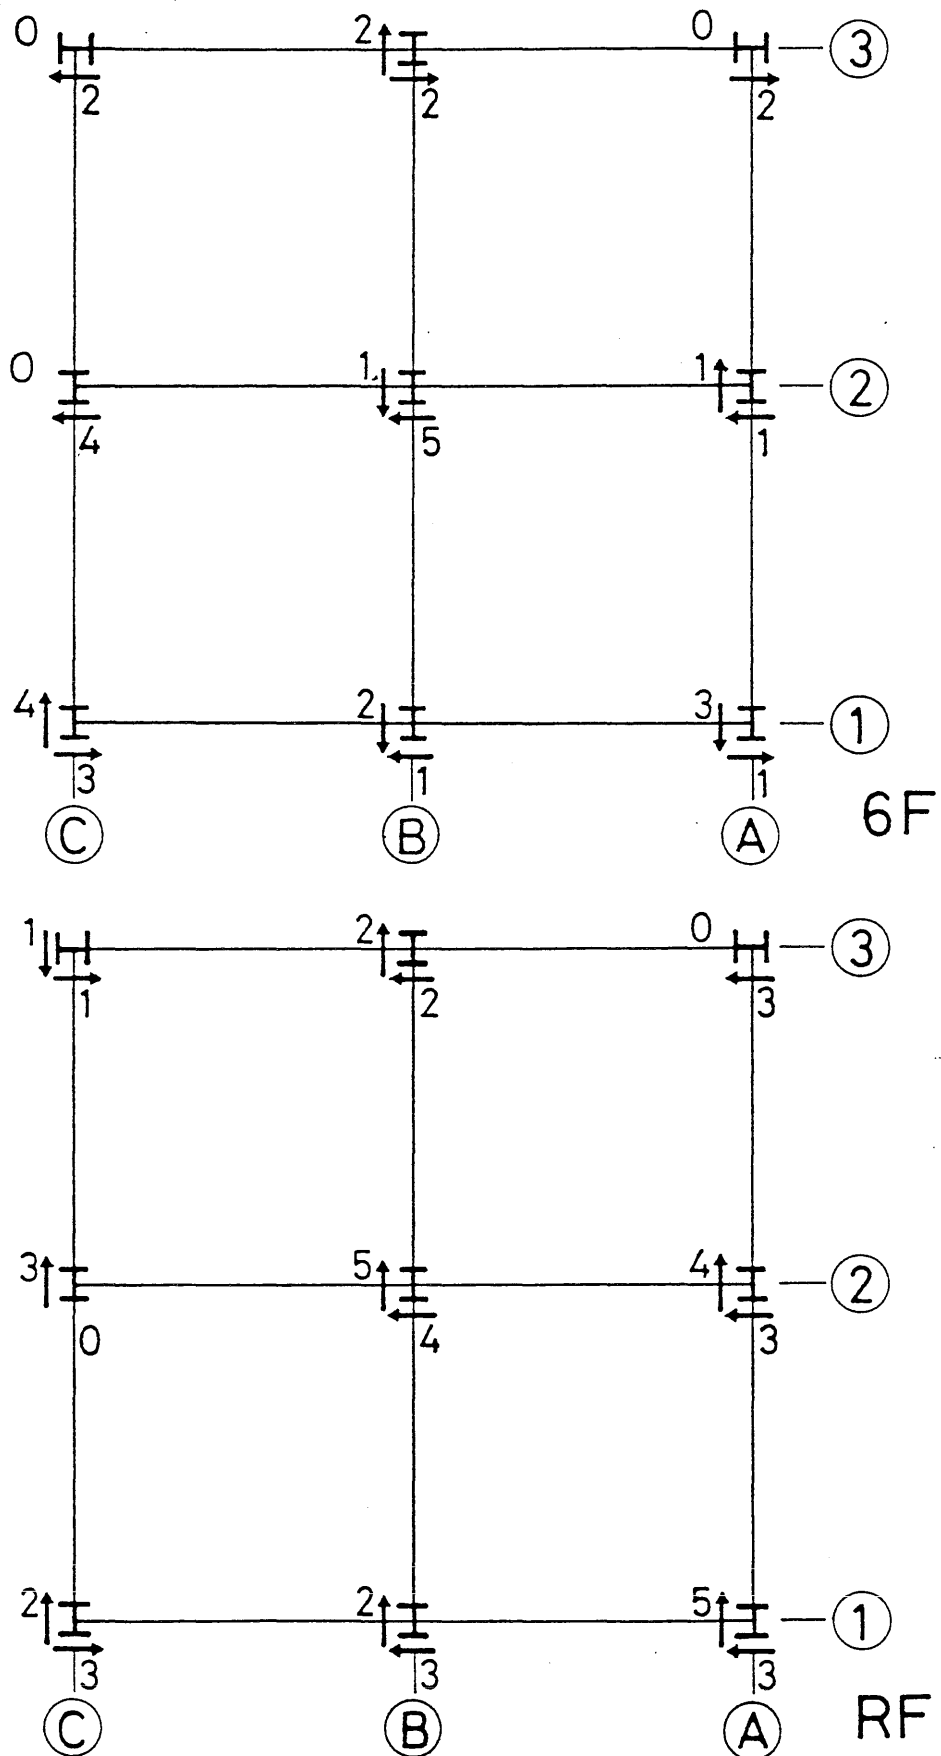
Fig. 2.16 Departures from vertical for the columns at the Z6 and ZF levels

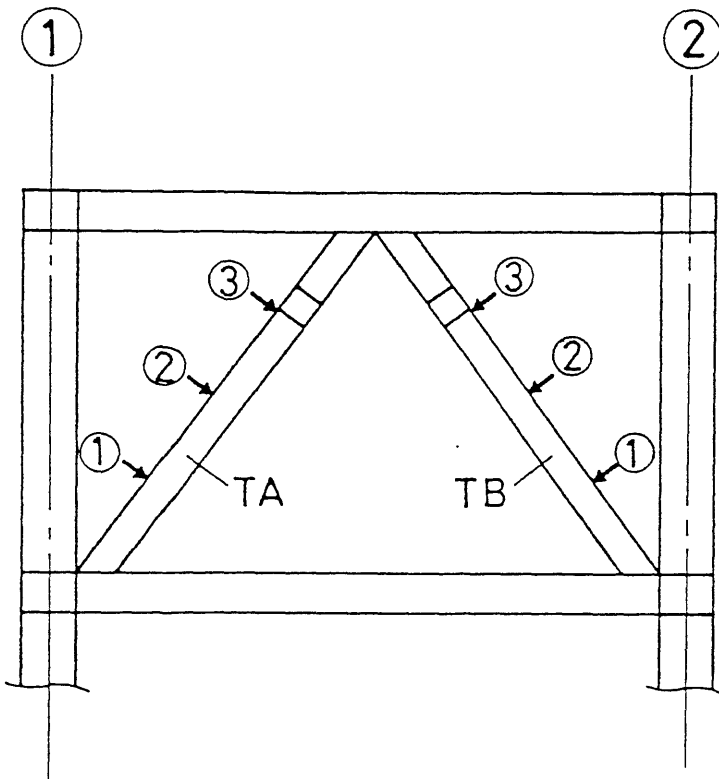
X direction			Y direction		
		①	②	③	①	②	③
ZR ~ Z6	TA	+4	+4	+3	0	0	-1
	TB	0	0	0	-1	-3	-2
Z6 ~ Z5	TA	+2	+3	+2	0	0	-1
	TB	-6	-6	-5	-2	0	0
Z5 ~ Z4	TA	-1	-1	-3	+1	+3	+4
	TB	1	0	+2	0	0	0
Z4 ~ Z3	TA	+2	+2	+2	+2	+2	0
	TB	0	0	+1	-8	-3	+1
Z3 ~ Z2	TA	-1	-4	-6	+1	+2	+3
	TB	0	+1	+2	-1	0	-1
Z2 ~ Z1	TA	0	-1	-2	+2	+2	+2
	TB	-1	-2	-2	+7	+9	+7

Fig. 2.17 Departures from a straight line for the
concentric braces of Frame B

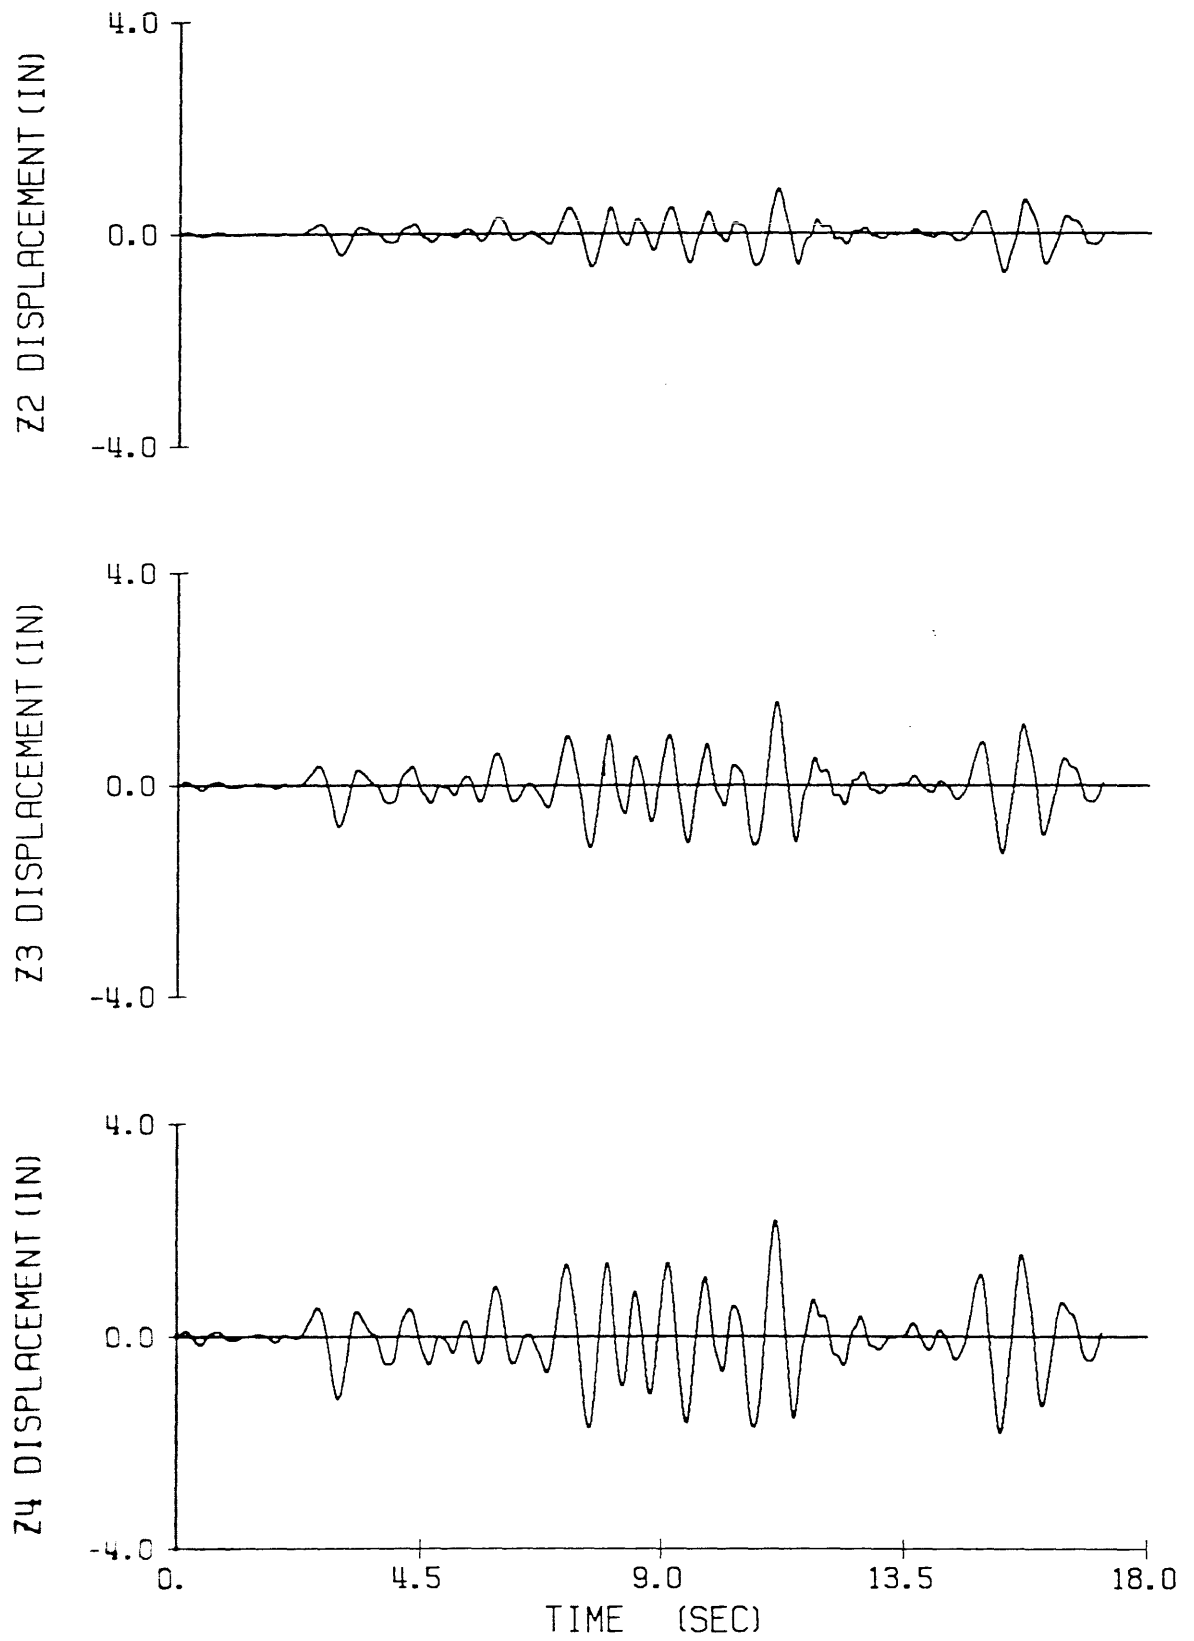
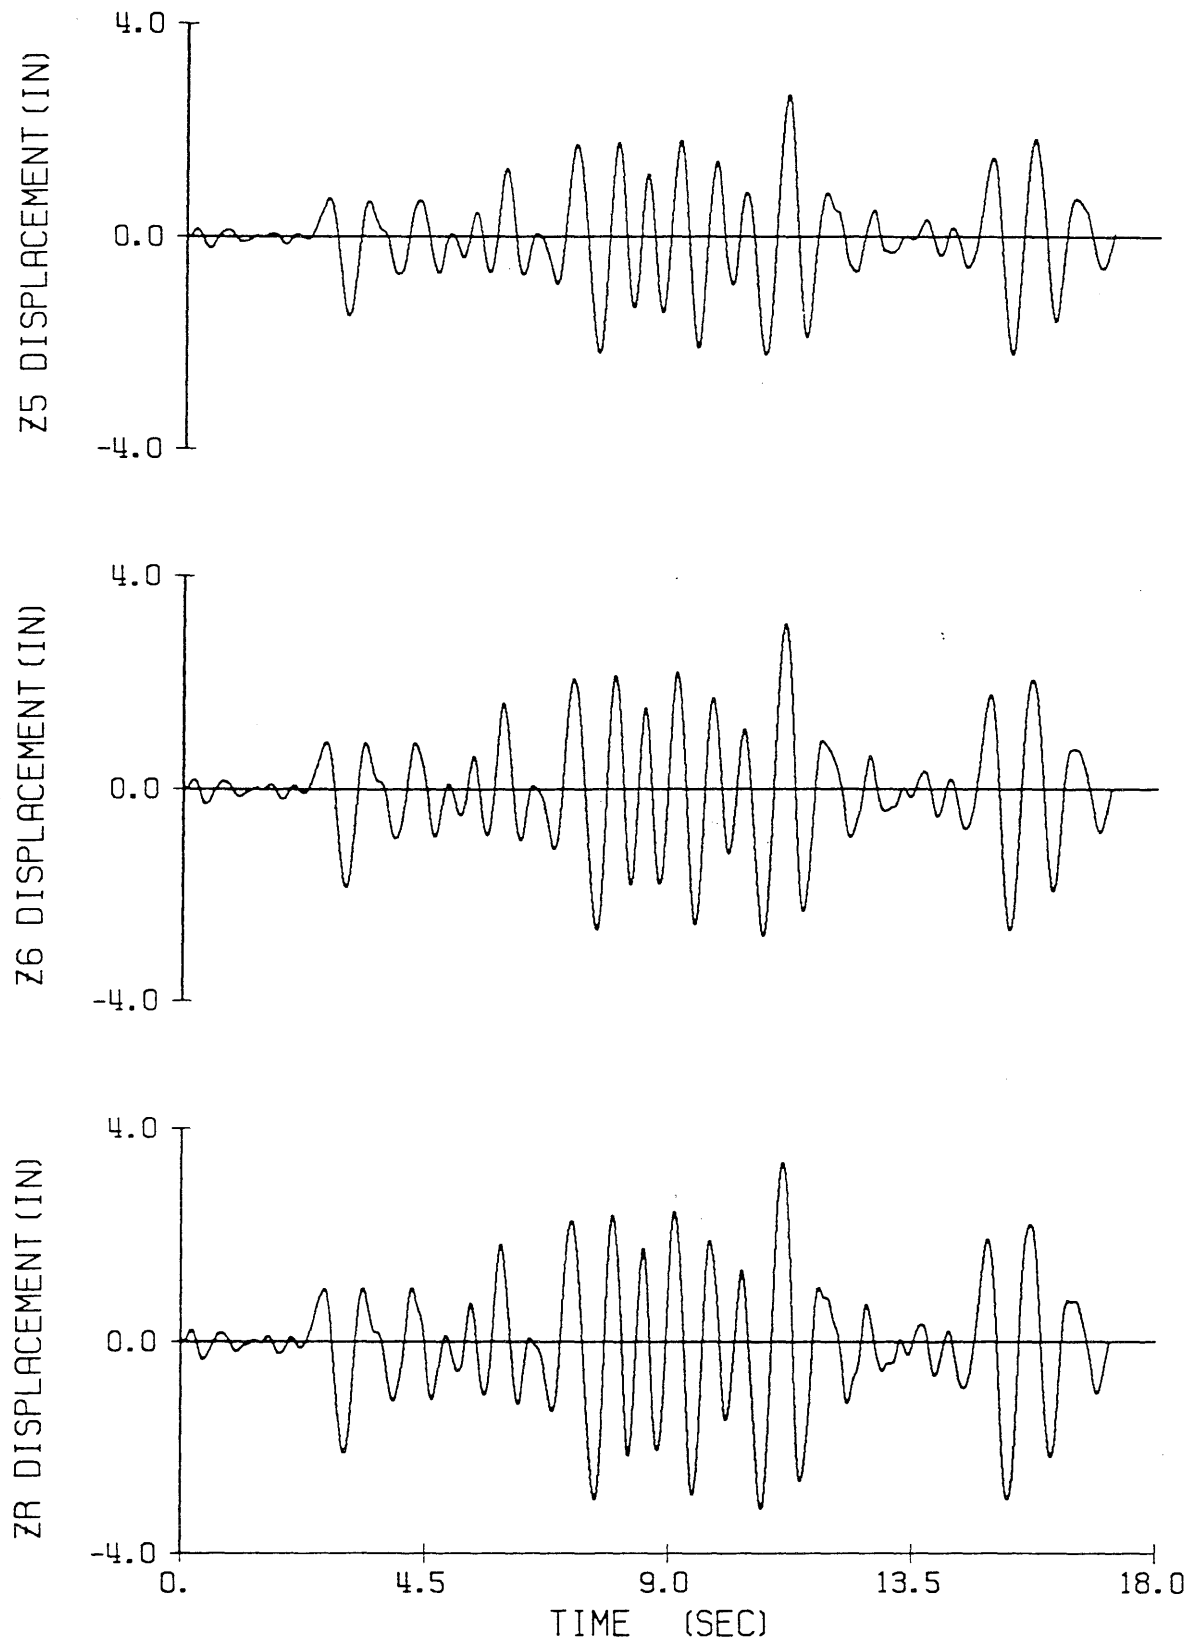
Fig. 4.8 Floor displacements vs. time for the Phase I Moderate test

The Moderate test was conducted next. The objective of this test was to generate a large enough response that brace buckling would be initiated at some locations. Further, this test should simulate the behavior of the structure during a moderate level earthquake which could occur at infrequent intervals during the life of the structure. The moderate test also provides important information concerning the relationship between the observed damage to the structure and its gross load deformation behavior. Plots of the displacement response of the floors are shown in Fig. 4.8. The shear force-displacement relationships are shown in Fig. 4.9-4.11.

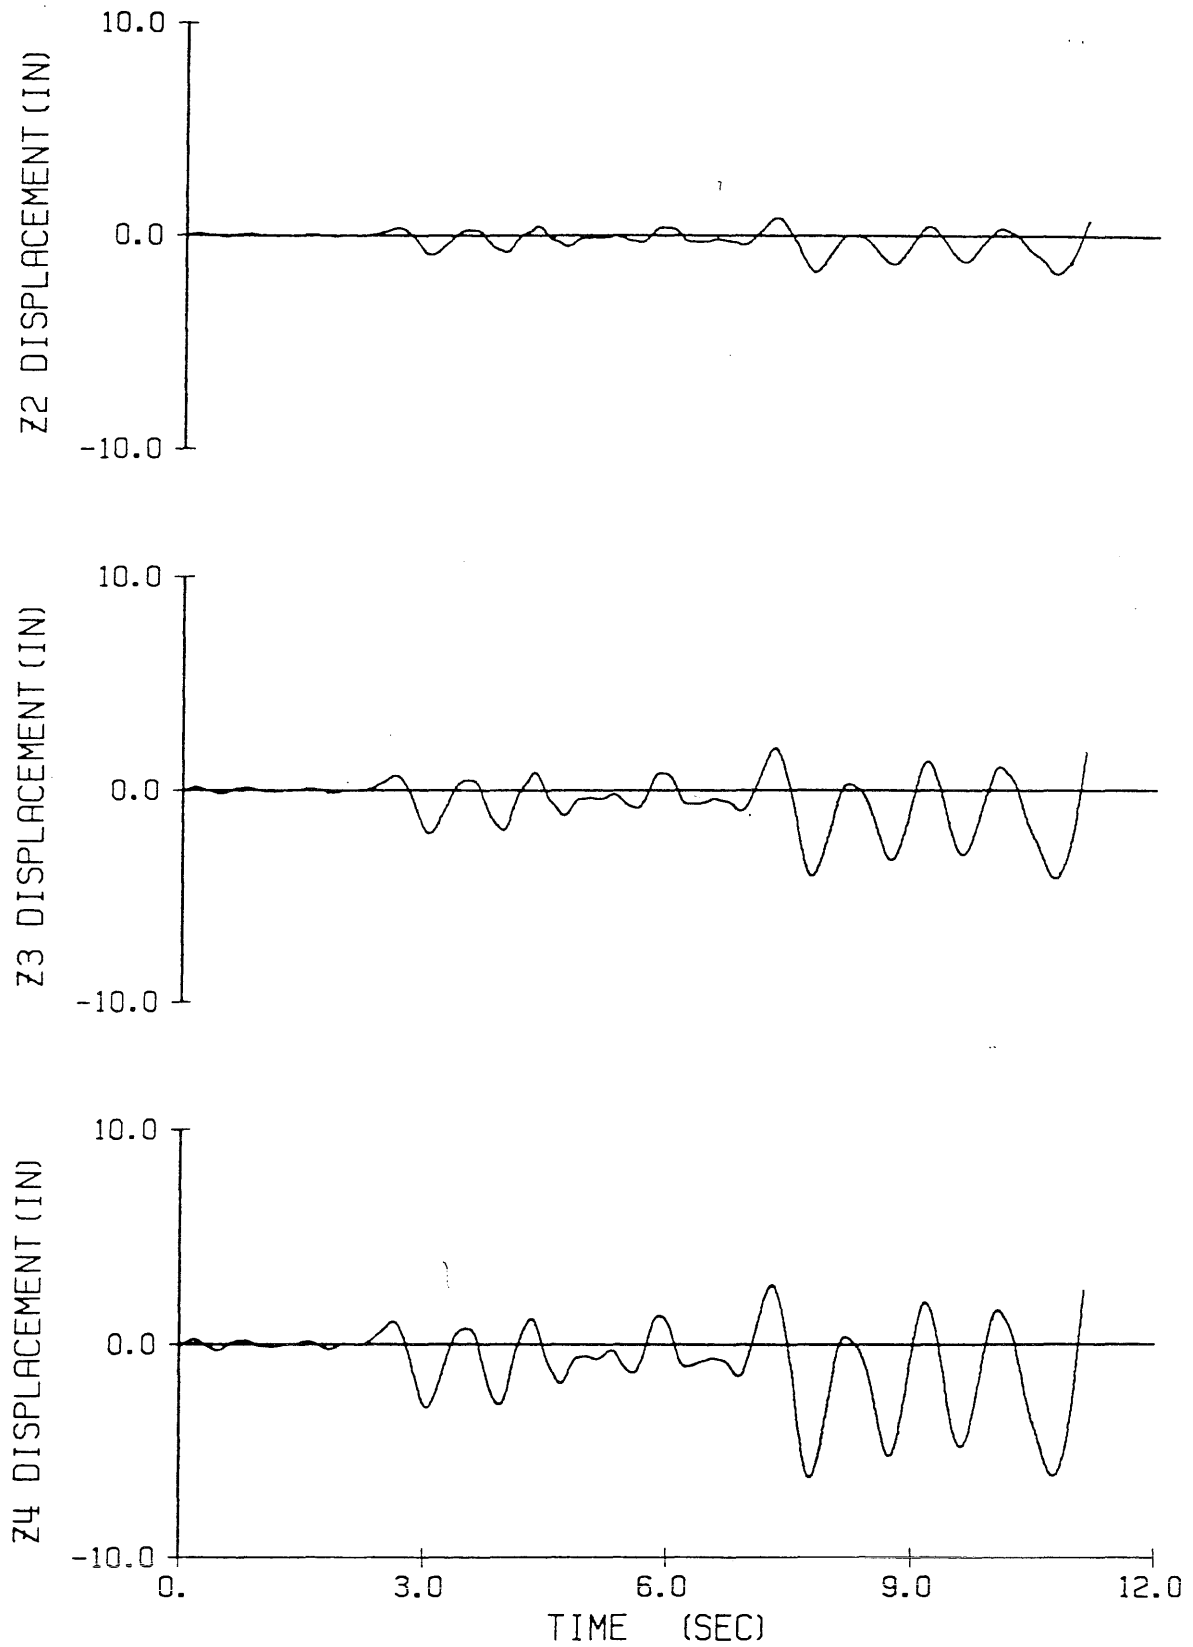
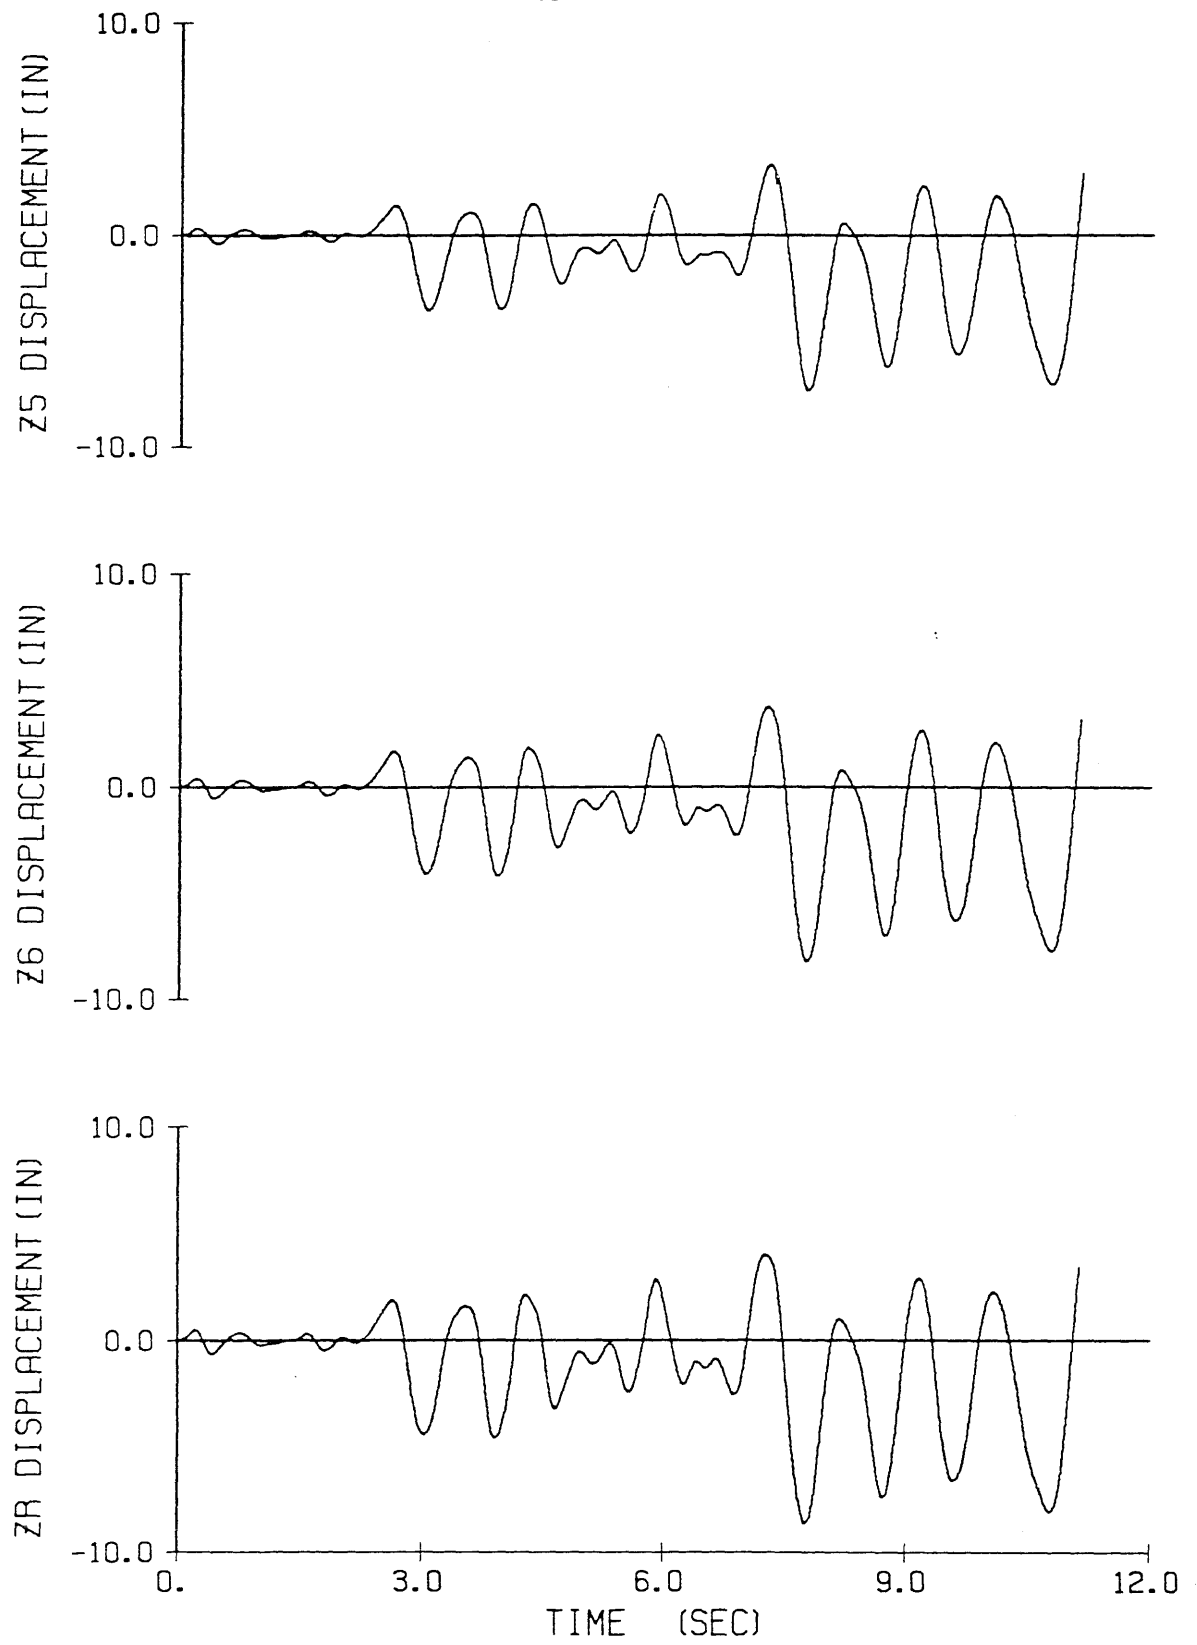
Fig. 4.14 Floor displacements vs. time for the Phase I Final test

Figure 4.14 shows the measured floor displacements as function of time for the Final test. The story shear force vs. displacement

relationships for all six levels are shown in Figs. 4.15-4.17 and a graphical summary of the damage is given in Fig. 4.18. Maximum deflections were approximately 3 times as large as those observed in the Moderate Test. Further, Fig. 4.14 shows that deflections were considerably larger to the north direction. Severe brace buckling was noted on the 2nd and 3rd levels during the first few seconds of the acceleration record because of the high energy input of the Miyagi-ken Oki acceleration records and because of the imperfections induced by previous testing. The braces of story 2 buckled out of plane and those of story 3 buckled in the plane of bracing. The braces were square tubes. Local tears initiated at the corners (see Fig. 4.19) because of high concentration of strains induced by plastic hinging of the brace and due to the reduced ductility from the forming process. This mode of failure appears to be consistent with observations from other research [8]. The tears and large lateral deflections of the brace reduced the stiffness of the 2nd and 3rd levels. This increased the deflection and story drift for these levels and caused further concentration of damage. A severely buckled brace is shown in Fig. 4.21 and local tearing at the bottom of a brace is shown in Fig. 4.22. The north brace of the 3rd level completely ruptured (Fig. 4.20) at 11.37 sec into the seismic record. The test was stopped at this point, even though some strength

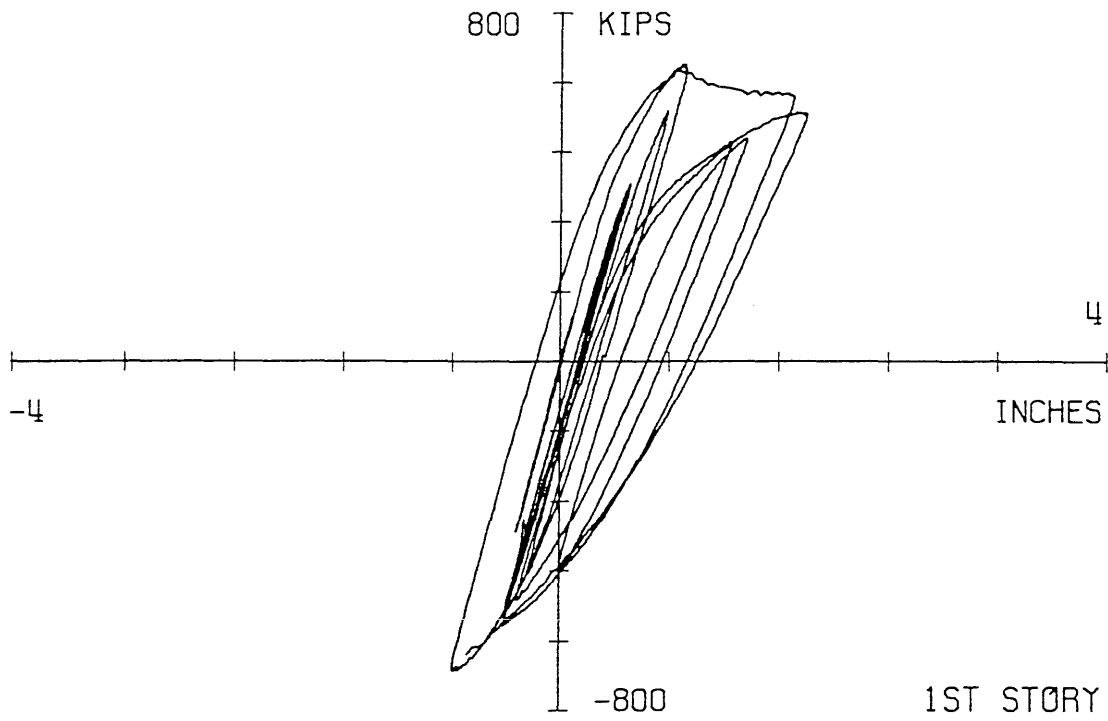
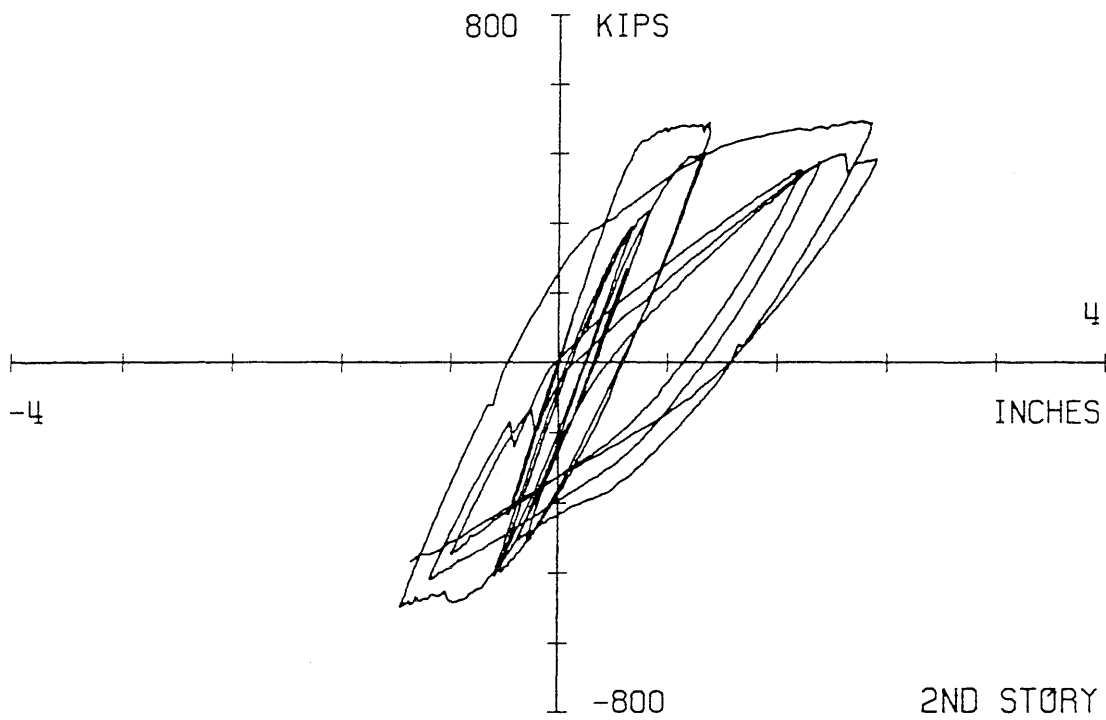
Fig. 4.15 Story shear vs. story displacement for the first and second stories for the Phase I Final test

loads due to walls and partitions. These loads were included in the initial gravity load design, and their absence results in a substantial increase in the reserve strength of the beams and columns. Figure 4.15 shows that considerable energy was dissipated in the lower levels and some deterioration in strength and stiffness occurred. Limited yielding could be observed in the center columns and in the beam column panel zones. This could be observed by the cracking of the paint coating on the steel surfaces. The summary of damage is shown in Fig. 4.18. However, this paint appeared to be very tough and ductile, so additional yielding most likely occurred at other locations. Inspections of the strain gage data will clarify this.

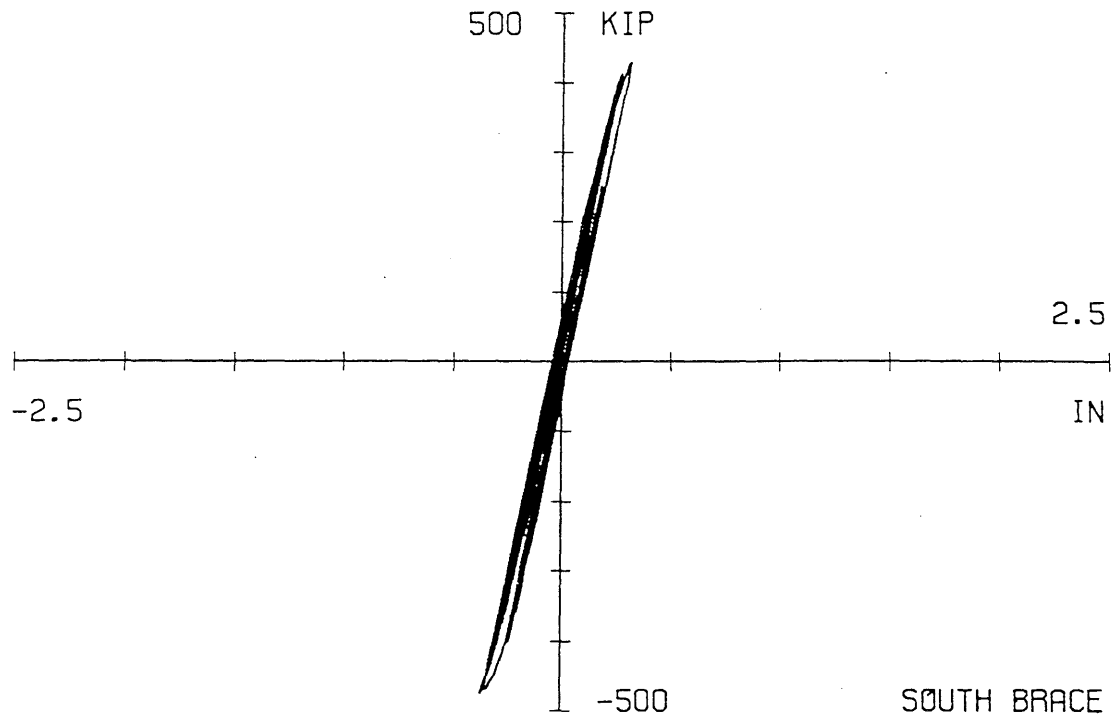
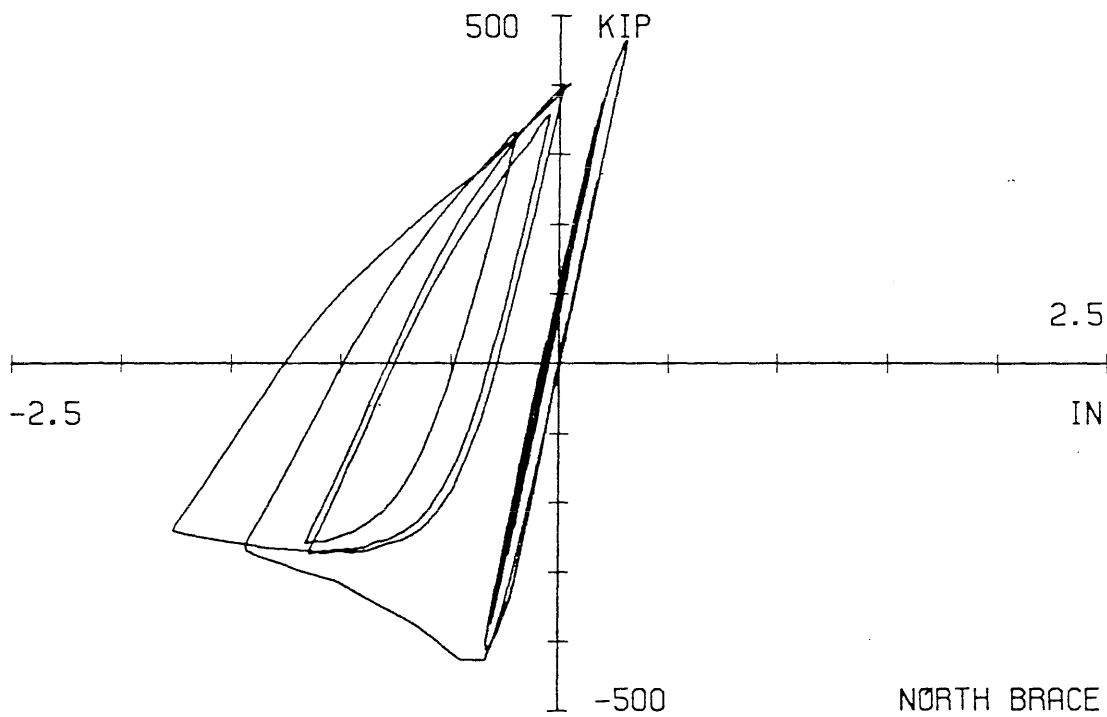
Fig. 4.26 Force-deflection relationship for the braces of the first story for the Phase I Final test

A rough idea of the energy dissipation mechanism for the building can be obtained by observing the responses of the individual members of each story level. The force-deflection response of each brace for the first story are shown in Fig. 4.26 and for the second story in Fig. 4.27. The moment-rotation response for the top and bottom of columns B1, B2, A1 and A2 are shown in Figs. 4.28-4.31, respectively and the panel zone response of each of these columns is shown in Figs. 4.32-4.35. These figures indicate that for the first story, the energy was dissipated by the braces, by hinging at the bottom of the columns and through panel zone deformation. In the second story, nonlinear brace and panel zone behavior accounted for the majority of the energy that was dissipated. The deterioration of strength and stiffness for each story may be attributed primarily to the brace behavior.

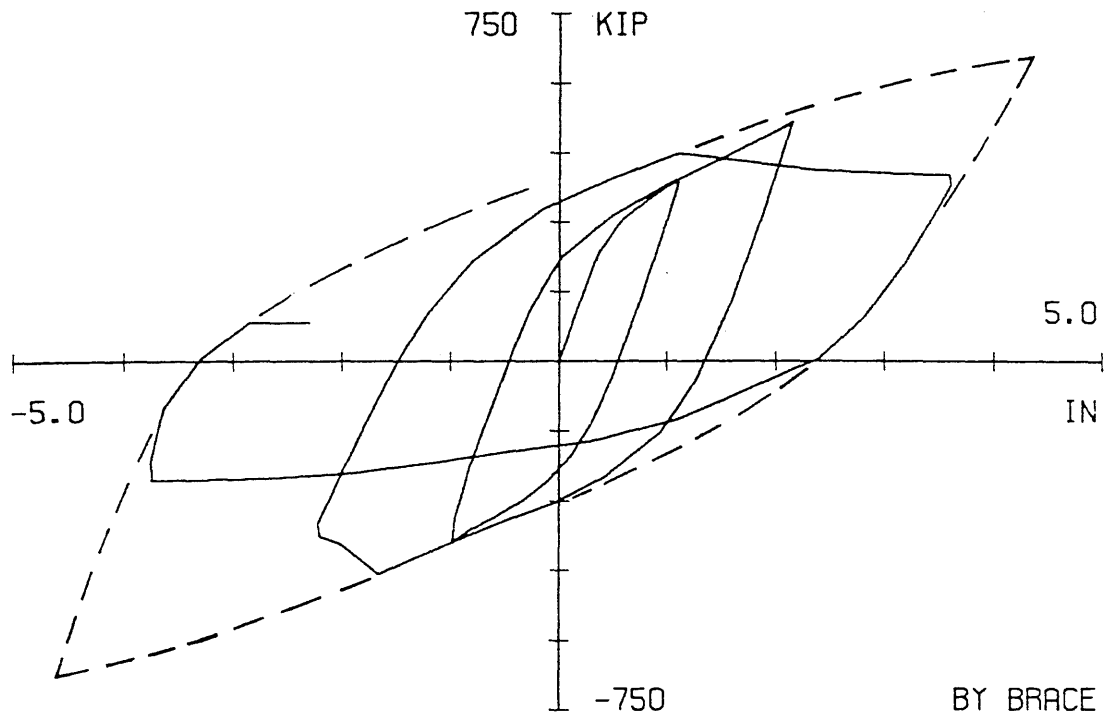
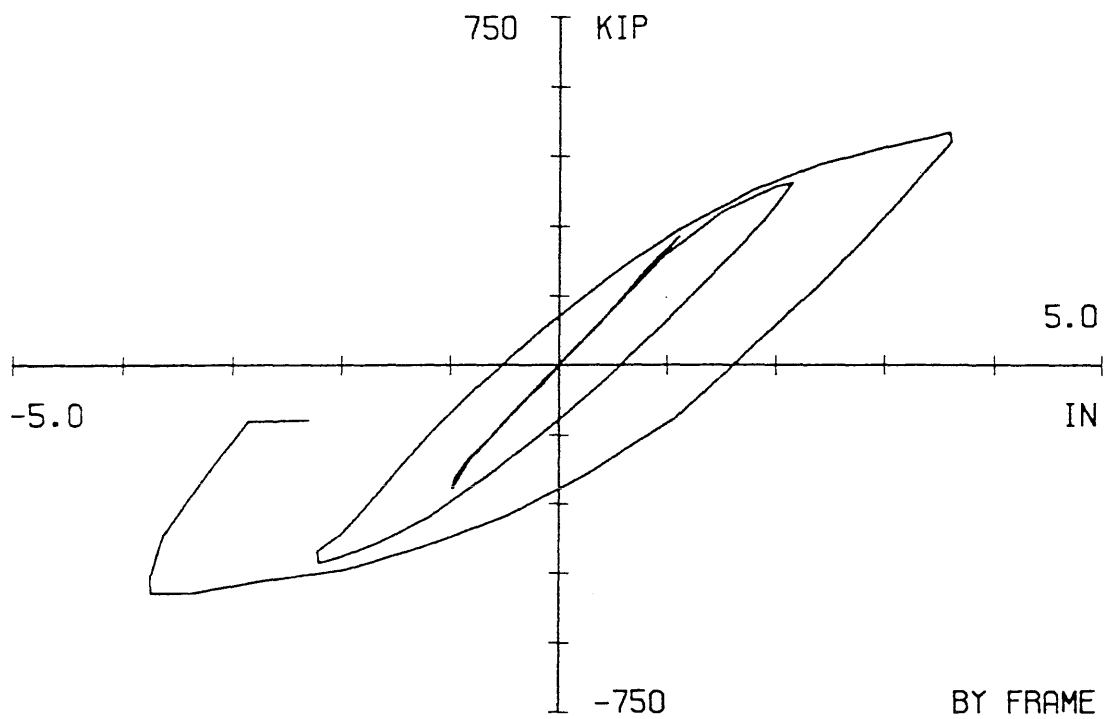
The effects of the buckled gusset plates can be seen in Fig. 5.27 which shows the shear vs. story displacement relationships for the braces and for the frames of the first story. The solid line for the braces represents the measured values and the dashed line represents the expected behavior without buckling of the gusset plates. The strength and energy absorbing capacity of the first story was significantly reduced because of the detail failure. Similar behavior was observed for the second story but to a smaller degree. The deterioration in performance of the structure would have been greater if lateral bracing had not been provided at each end of the link.

Fig. 5.27 Story shear vs. story displacements as carried (a) by the braces and (b) by the moment frames of the first story during the Phase II Sinusoidal tests

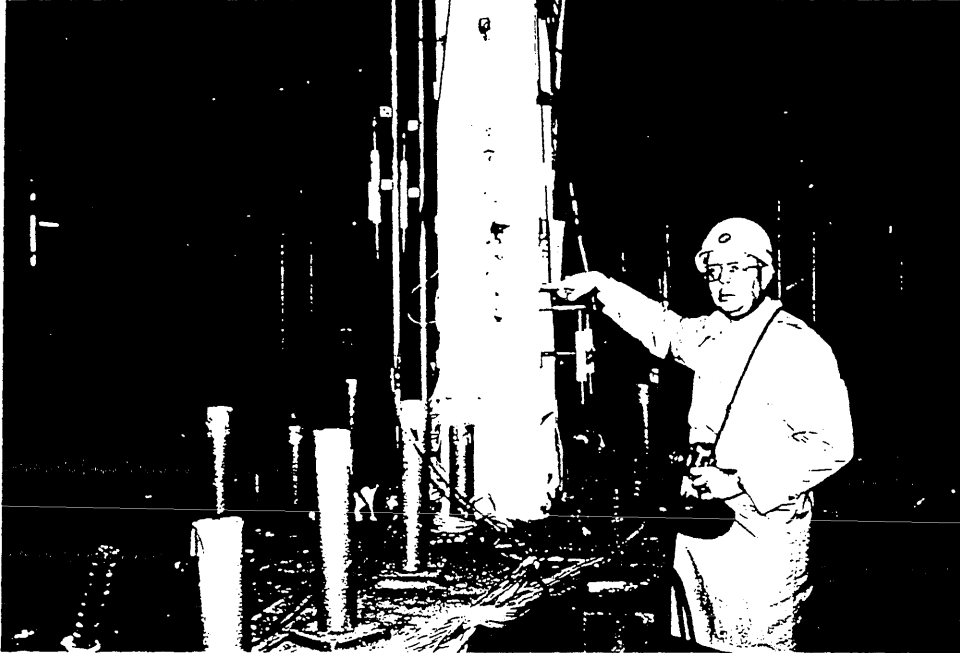
Fig. 5.31 Yielding at the bottom of the B2 column
during the Sinusoidal tests

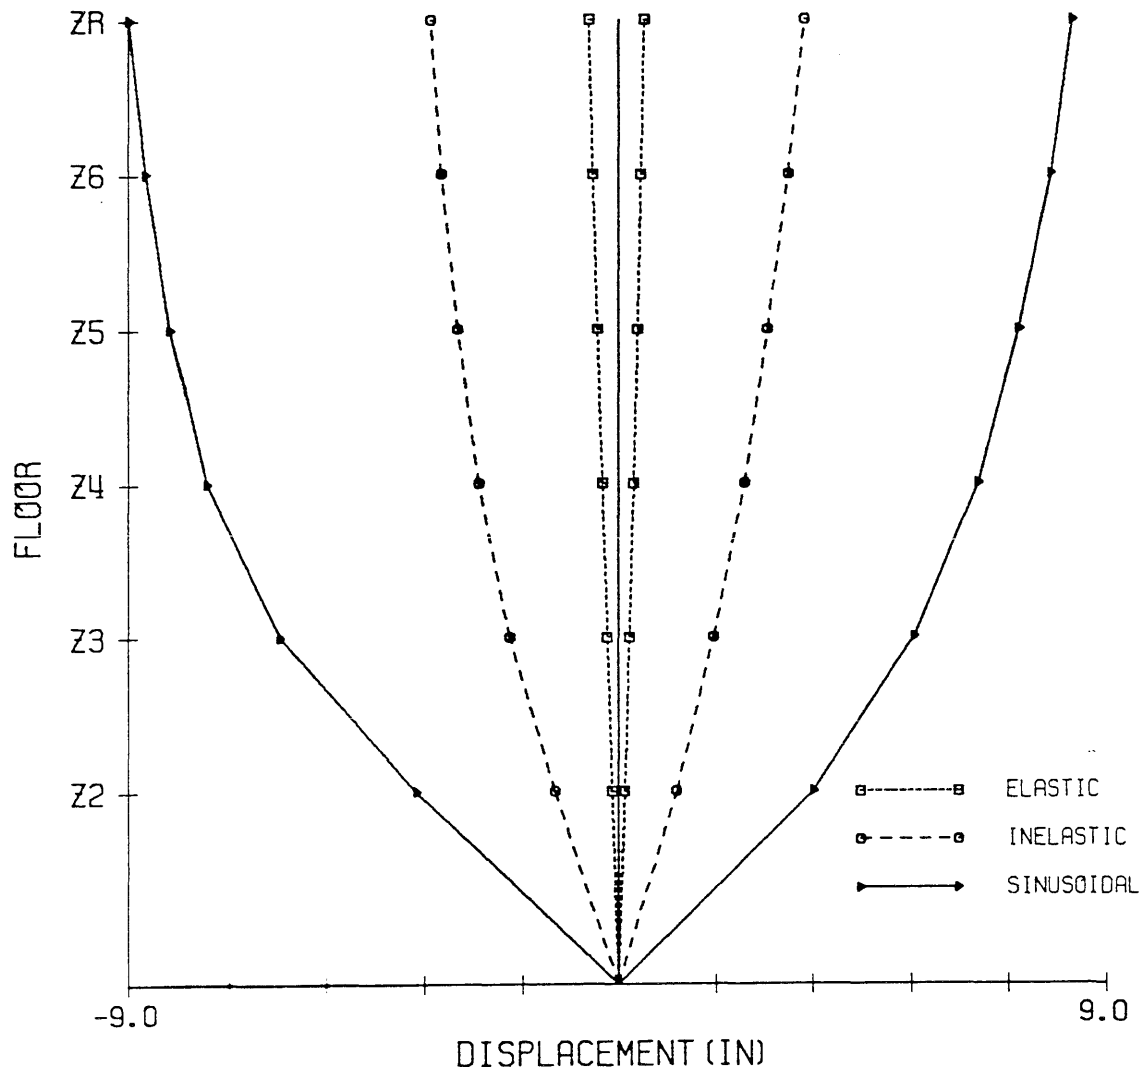
Fig. 5.44 Envelope of maximum story displacements for the Phase II tests

The maximum story displacements and the maximum story drifts for the Elastic, Inelastic and Sinusoidal tests are shown in Figs. 5.44 and 5.45, respectively. These figures indicate that, even with the gusset plate failures, the structure demonstrated excellent ductility. The figures also reveal that the structure was not an optimum design. Most of the energy dissipation occurred in the first three stories. For an optimum eccentric braced frame, the maximum story drifts would be nearly equal at all levels and all stories would participate equally in the energy dissipation.
